**Report:** Sample Report

# **Inspection Report**

## **New Home**

### **Chattanooga, TN 37421**

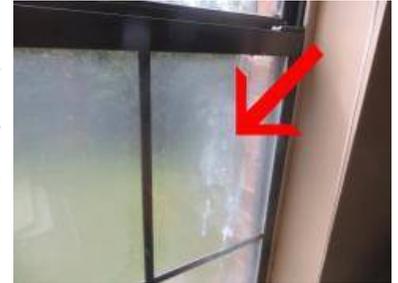
*TYPE & CONDITION:* Vinyl, Double pane, Single hung (only the bottom window opens), A representative sampling was taken. Windows as a grouping are operational. The master bedroom window thermal seal is damaged. Note the hazing/condensation between the glass panes. This is more of a cosmetic issue than a maintenance issue, however you may want to replace the glass.

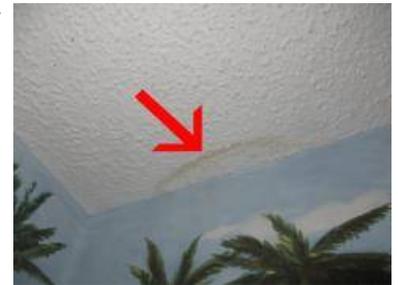
*TYPE & CONDITION:* Drywall, General condition appears operational, Dry stain noted on the upstairs bath ceiling. No leaks found overhead. Appears to be from an old leak. Inquire with seller/monitor.

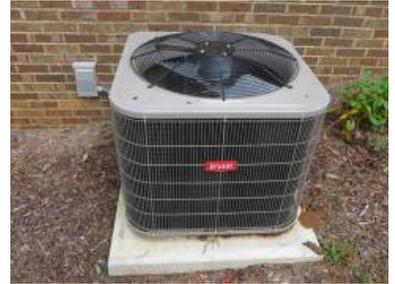
TYPE: Central, Electric, Operational.

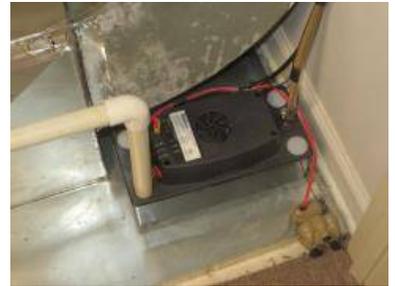
CONDENSATE LINE: Condensate line installed, There is a pan installed below the interior unit. The pan is equipped with a safety float switch which will shut the system down in the event that the condensation drain line is not draining and water begins to accumulate in the pan. The float switch was not tested, Condensation pump installed. Appears operational.

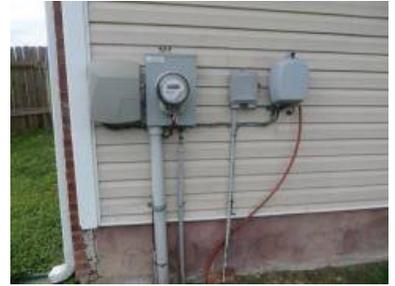
Underground service to the structure. Contact the utility company to mark the location of underground cable before digging.

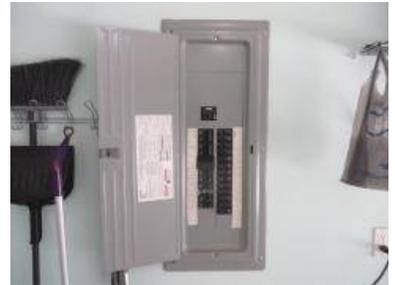
Basement, Operational.

Circuit and wire sizing correct so far as visible, Grounding system is present, 200 amp main.

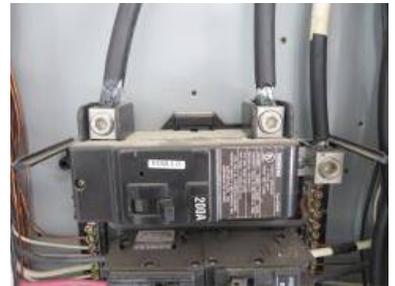
Aluminum, Operational.

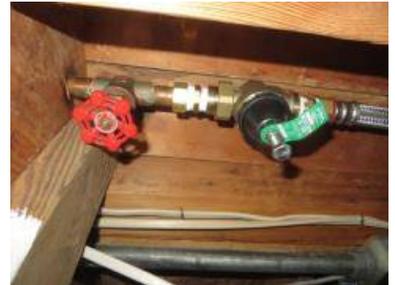
*MATERIAL:* Copper, Pressure reducing and shut off valves are located in the basement.

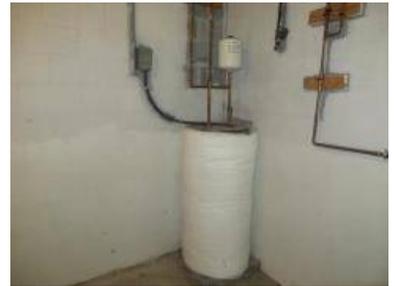
*TYPE:* Electric.

*CONDITION:* Operational, Pressure relief valve noted, not tested, Thermal blanket installed - unable to fully view tank, A water shutoff valve is installed.

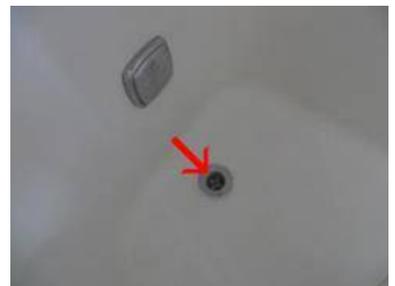
Appears operational, The bath tub mechanical drain stopper is missing. Recommend repair.
